Jaguar E-type Restoration - Part 2

Jaguar E-type 4.2 restoration by Spotless Automotive Restorers, Knysna, South Africa

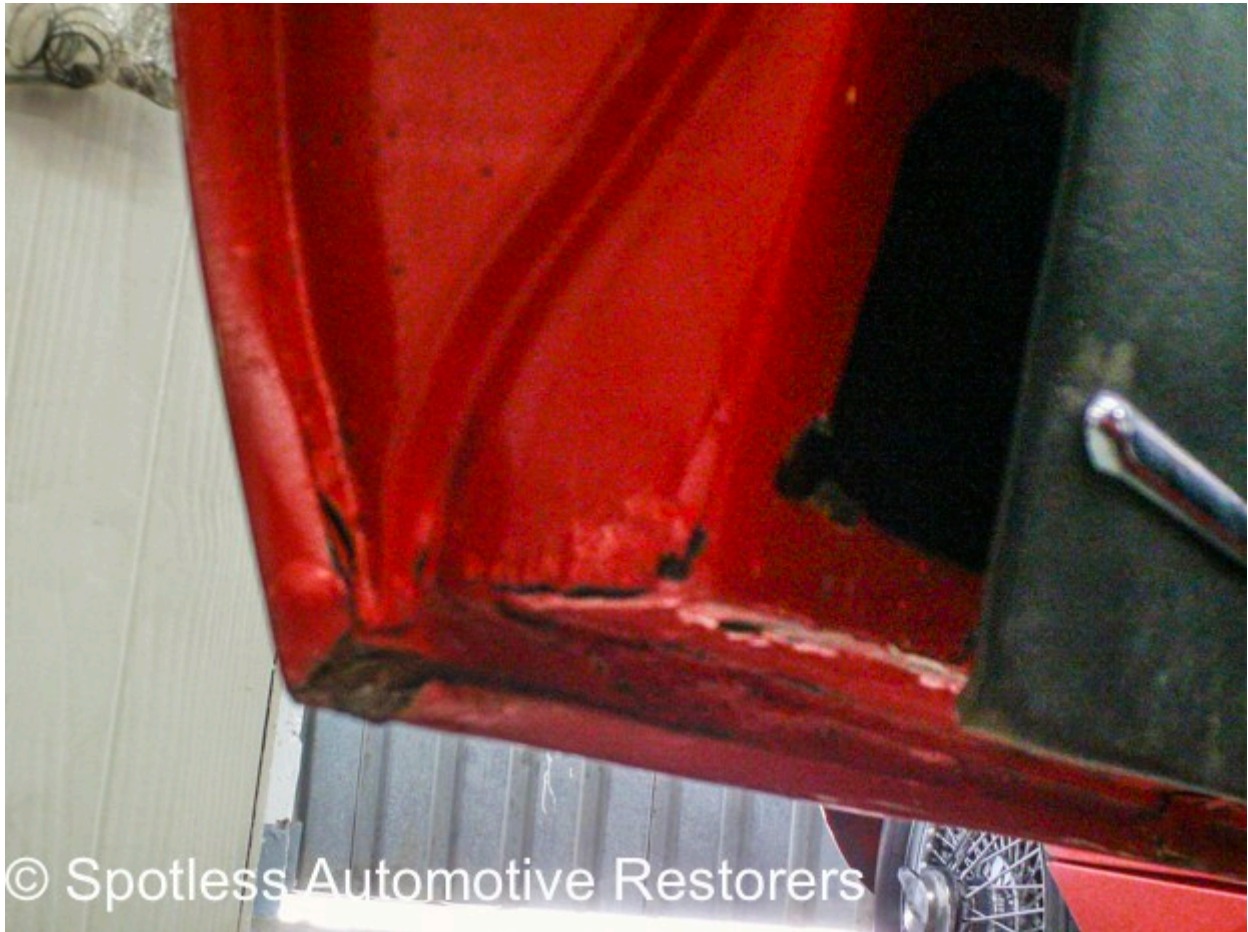
Jaguar E-type 4.2 passenger door rust

Upon arrival, the Jag E-type did not have any apparent damage and at first glance one could say that it was in top form - the chances of discovering any rust and corrosion during the stripping process could be expected to be minimal. When Francois proceeded with stripping though, he noticed the left door was rust-ridden on the bottom inside, this would need to be re-manufactured and welded. Chroming of the E-type was in great condition, but the majority will nevertheless be sent away for re-chroming. Even though the rubbers were in good condition, a brand spanking new rubber kit was ordered to replace the previous one. The shut lines of the E-type were in top condition, which is fantastic news for the team as this will ensure a seamless re-assembly process.

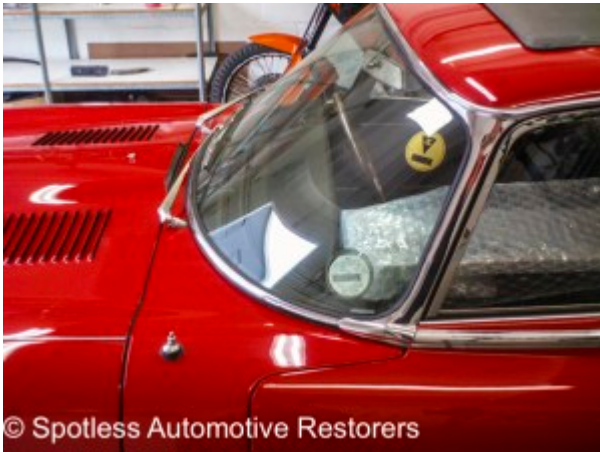
© Spotless Automotive Restorers
Jaguar E-type 4.2 windscreen chrome

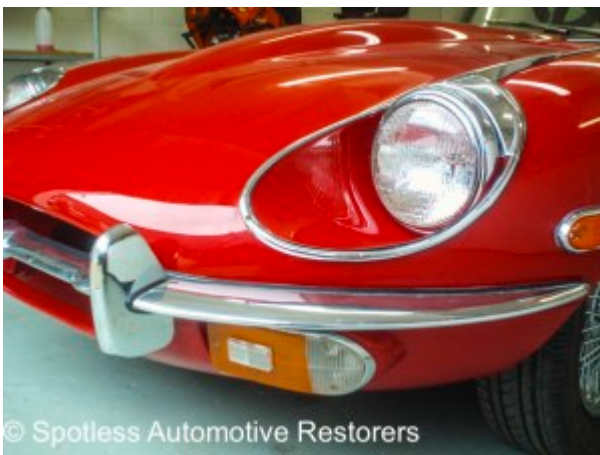
© Spotless Automotive Restorers
Jaguar E-type 4.2 headlamp and brightwork

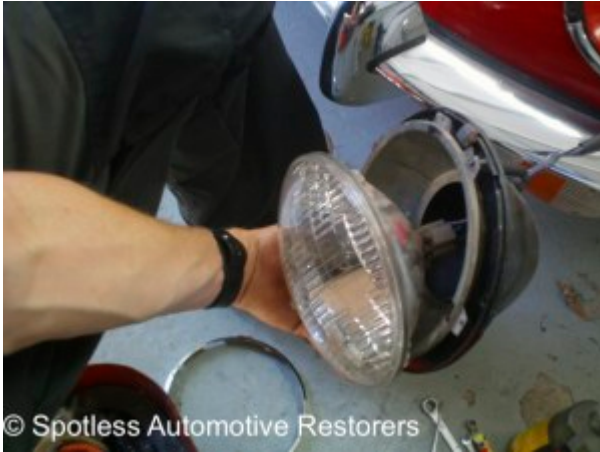
Jaguar E-type 4.2 headlamp being removed

Over a period of a couple of weeks Francois spent much time bent and hunched over her, carefully taking off each piece to be reviewed, bagged and tagged for re-assembly. Starting with the outside lights, he took photos as he went along to ensure that all the wiring and pieces would go back exactly where he removed them from. All the pieces removed during this painstakingly precise process will either be placed in storage, sent for painting, cleaning, welding or chroming. After the outside lights, he removed the chrome trim, door parts for chroming and all the inside mechanisms.

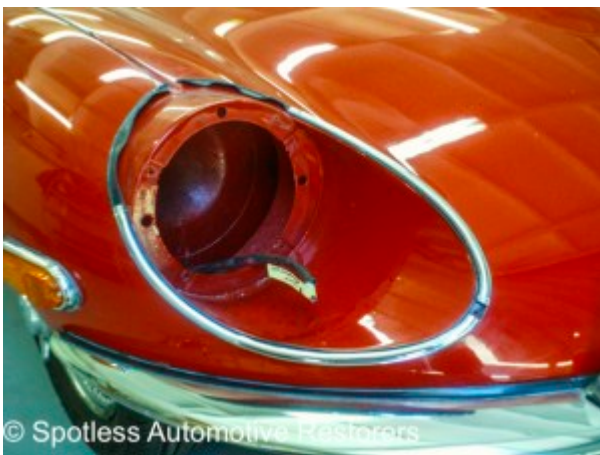
Jaguar E-type 4.2 headlamp removed

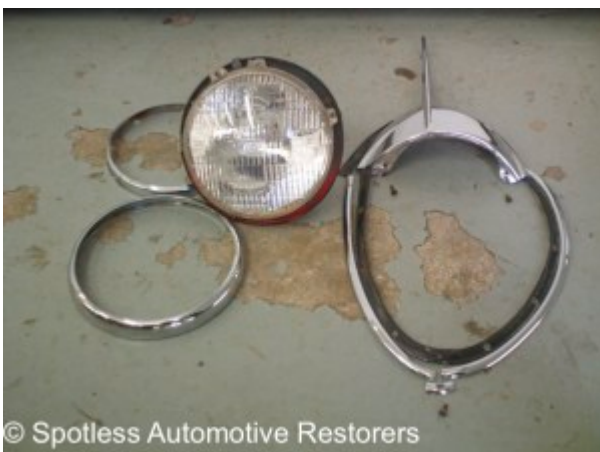
Jaguar E-type 4.2 headlamp components

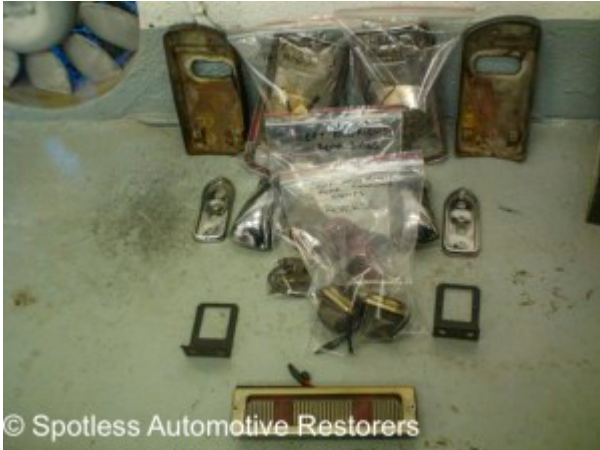
Jaguar E-type 4.2 components 'bagged and tagged'

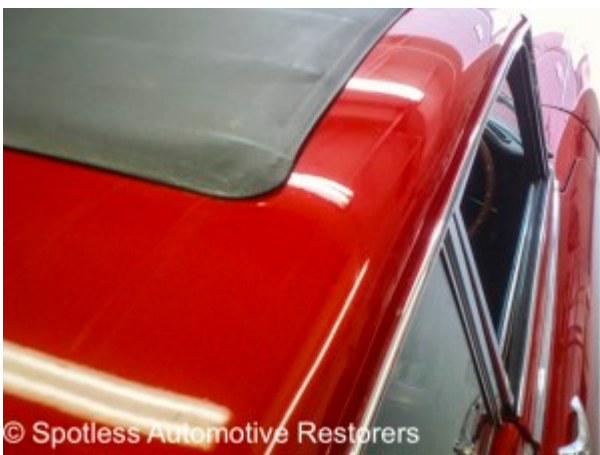
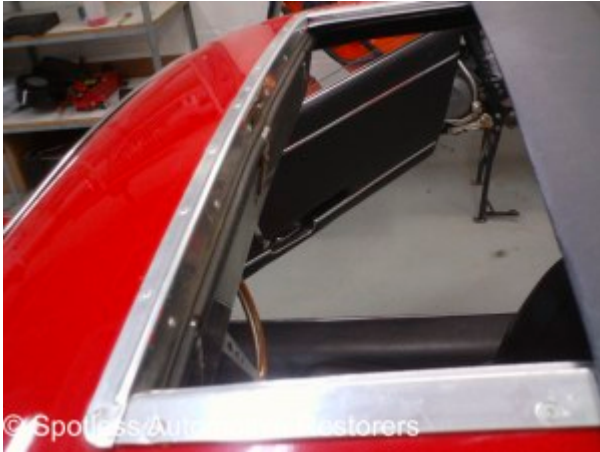
Jaguar E-type 4.2 Britax sunroof

Moving to the interior, Francois removed the seats, carpets and boot liners. Dismantling the soft top Britax sunroof was a breeze. Francois said, “The soft top sunroof came out a lot easier than a Webasto soft top with only four channels to hold it together - once the aluminium channels are out, there is no support around the edges of the opening, which might become a problem when prepping the roof for paint later on.”

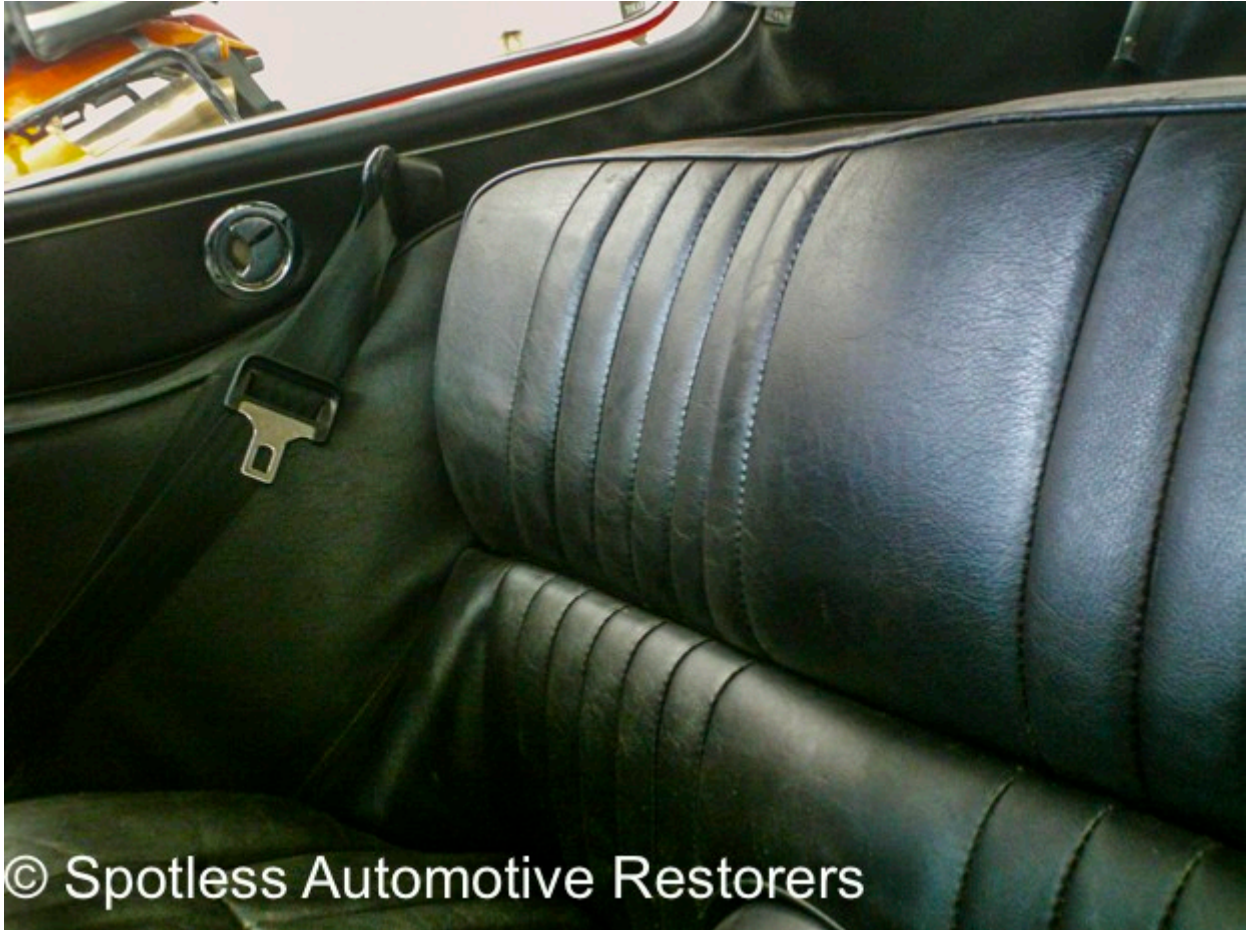
Jaguar E-type 4.2 rear seats have hardly been used, and were in excellent condition

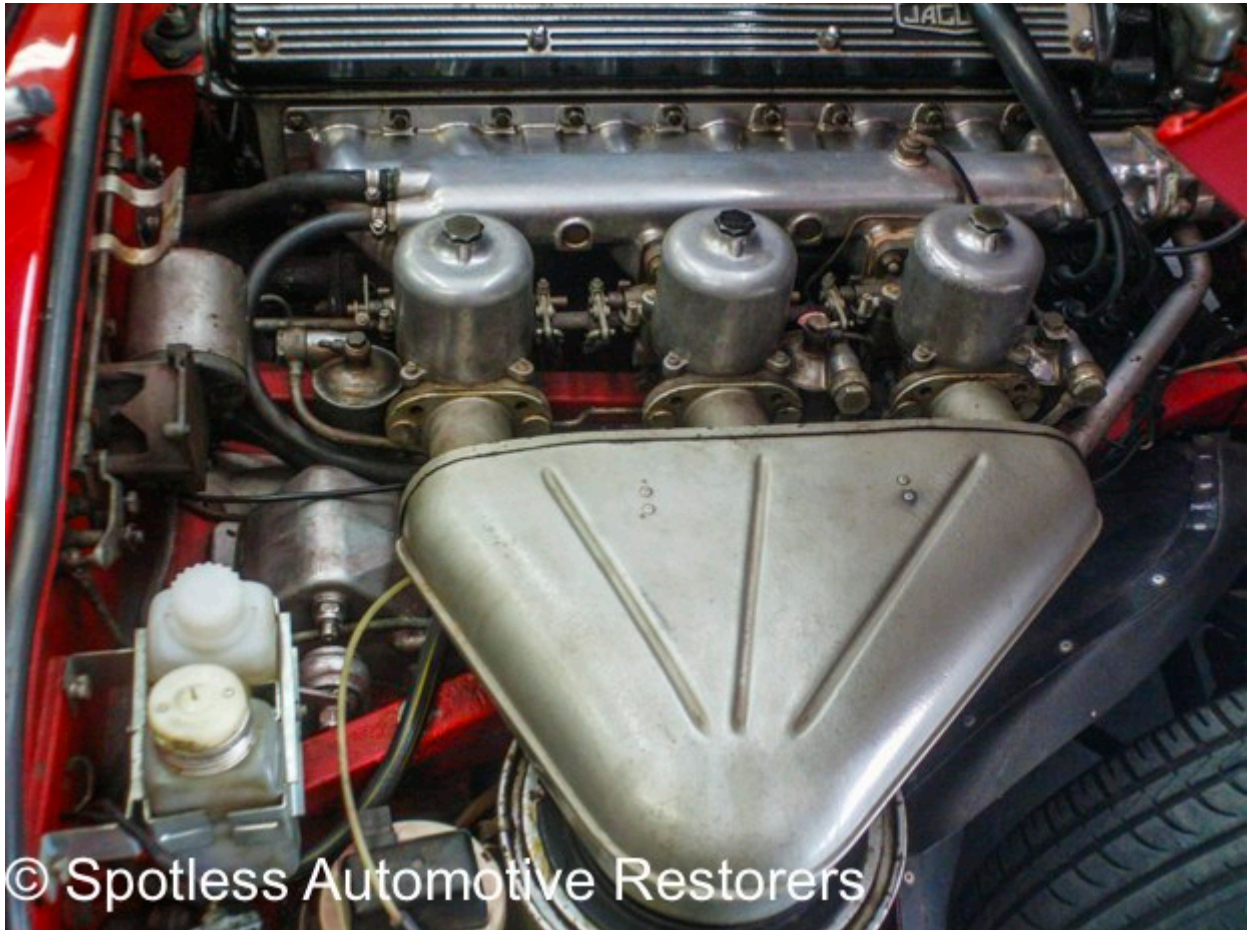
Jaguar E-type 4.2 engine bay
