Jaguar E-type Restoration - Part 3

Jaguar E-type 4.2 restoration by Spotless Automotive Restorers, Knysna, South Africa

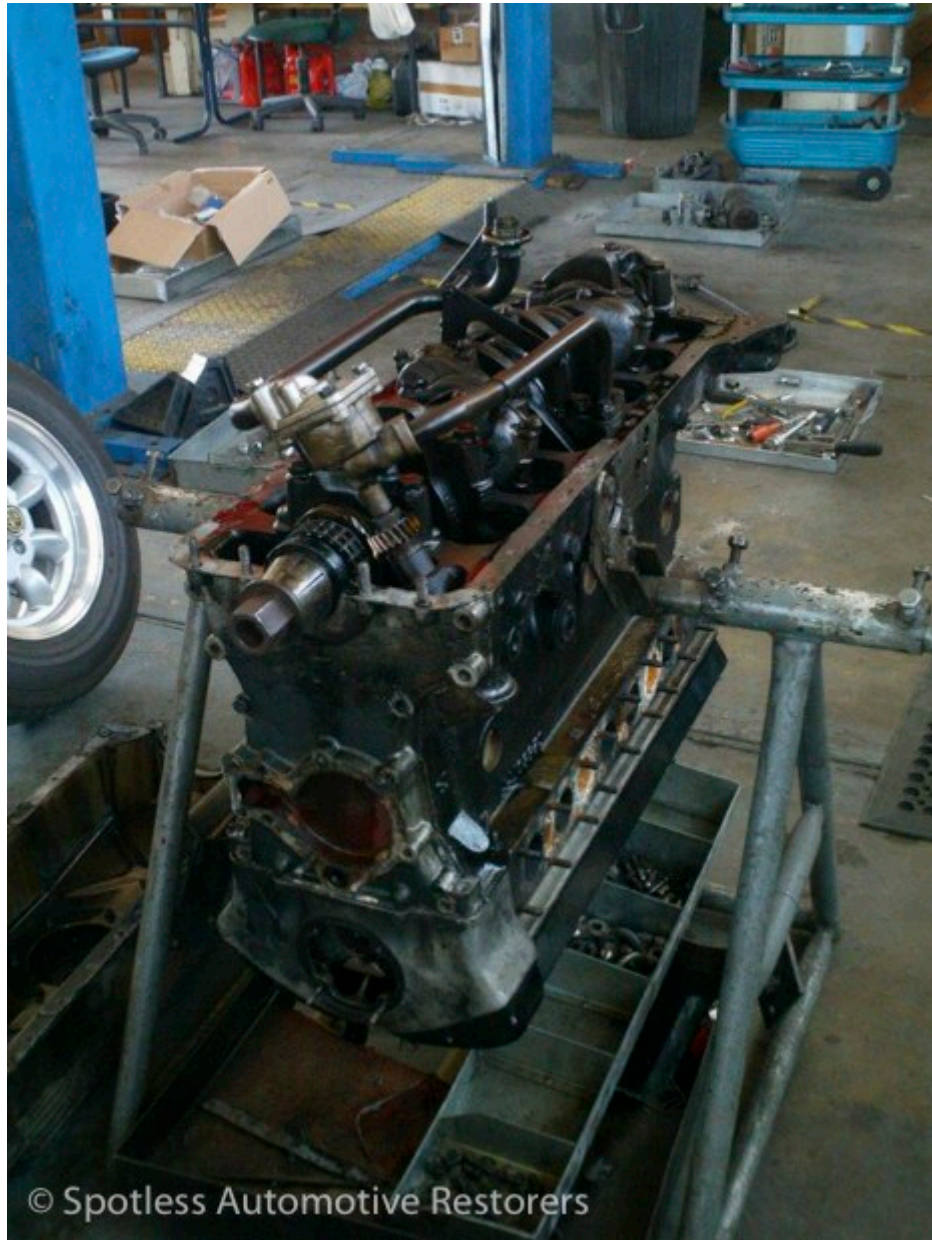
Jaguar E-type 4.2 restoration by Spotless Automotive Restorers, Knysna, South Africa

Stripping down all the mechanical parts is just as much an arduous, meticulous process as with the stripping of the body, if not more so. Ron explains how they started with removing and stripping the engine, inspecting each part and how they made a comprehensive list of

spares needed. This process was repeated with the gearbox, back suspension, front suspension, and clutch system and so on. The parts that weren't replaced were thoroughly cleaned, removing all the grease by sandblasting or brushing it, ensuring the part is spick and span and back to standard. Each section of the car, like the engine for instance, has a dedicated area in the workshop where all the parts are laid out. Once all the parts that need to be replaced have been received, the engine will be put back together, using new seals and gaskets, mounting brackets including all the pieces that would go back first into the shell of the car. Ron explains that the whole process entails a lot of liaison between the client and the other parties working on the car. Some of parts would be sent to Spotless for painting.

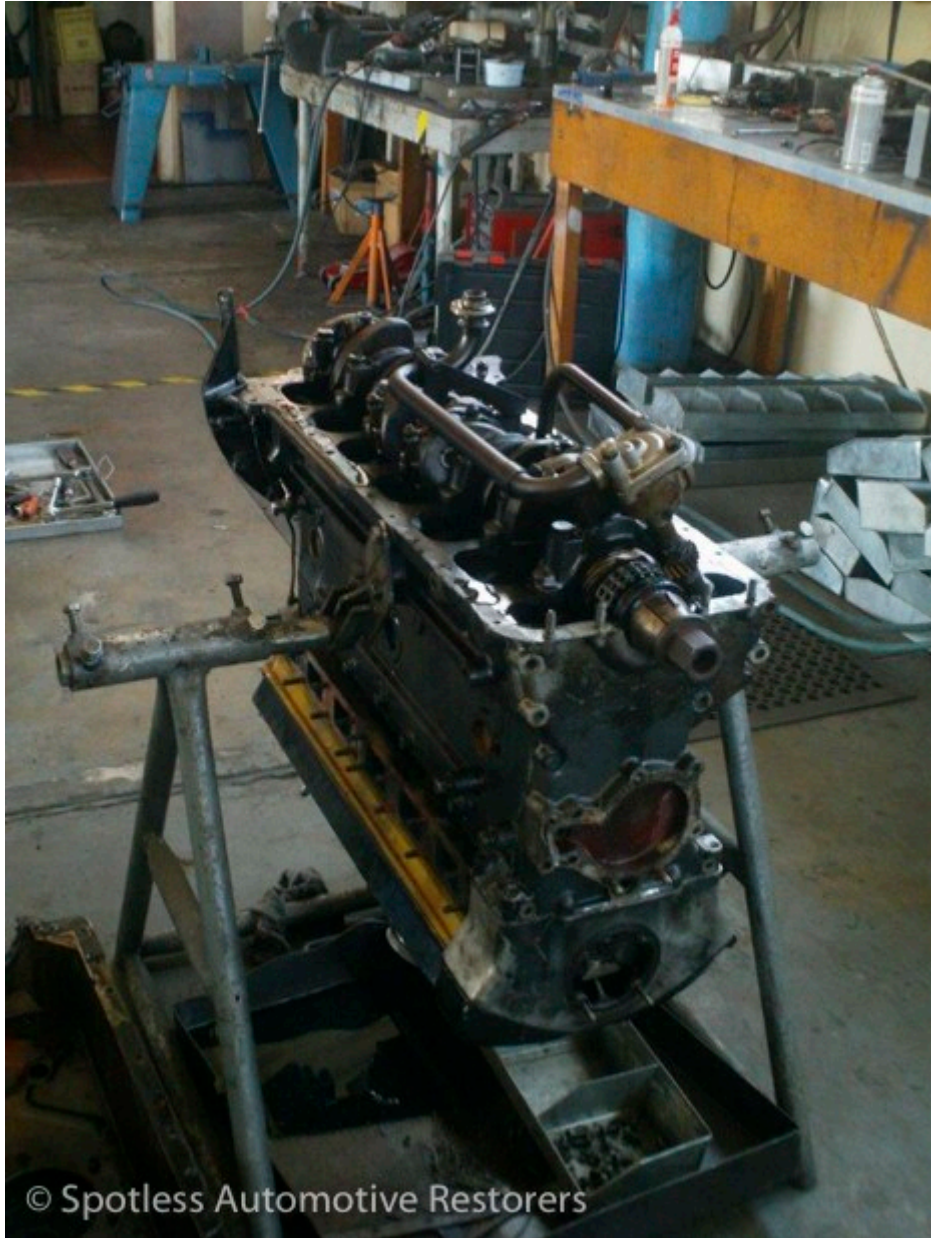
Jaguar E-type 4.2 restoration by Spotless Automotive Restorers, Knysna, South Africa

As parts are cleaned, inspected and new ones are received, the team starts preparing to insert the sub-assembly, including the wiring loom and brake pipes. Ron explains that it is critical to have maximum access to install and put all the pieces back together as the car is literally built from the inside out. Then they start on commissioning each of the systems, for

instance the fuel system by putting fuel in the tank to check for leaks. The front brake circuit is then bled, followed by the rear brake circuits. This ensures the pressure is correct and that there are no leaks. Each of the electrical components of the car is completed and systematically checked.

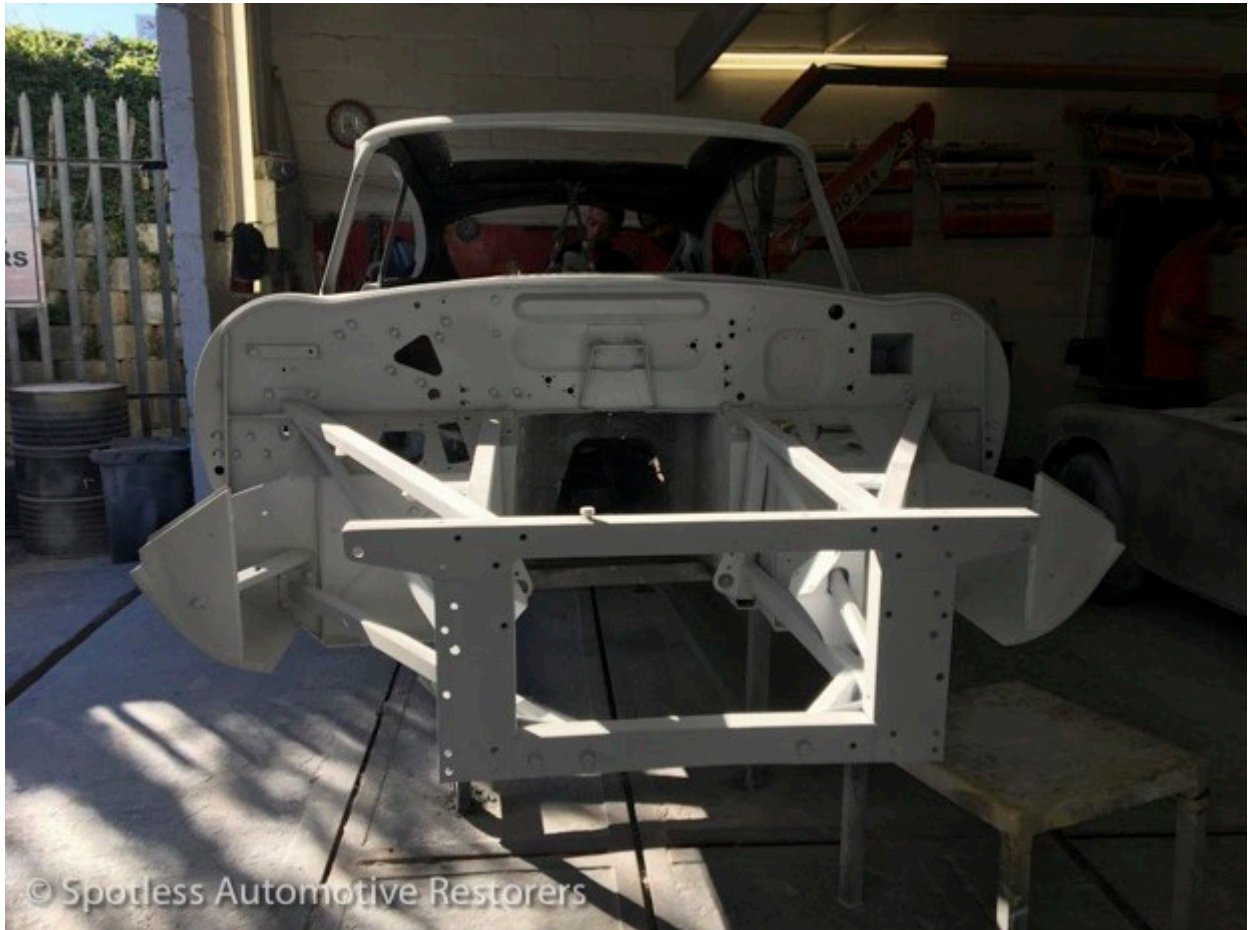
Jaguar E-type 4.2 restoration by Spotless Automotive Restorers, Knysna, South Africa

The team at Spotless have stripped the E-type down to bare metal. Once completed, everyone was pleasantly surprised by the mint condition of the bonnet. They even went so far to say that it is one of the best bonnets they have seen with very little to no rust - compared to many other classic cars they have done work on in the past. The doors, as previously noted, had quite a large amount of rust, and required either complete replacement or remanufacturing. The latter has been done by Spotless' Bruce Smith, a professional artisanal welder. At the time of writing, some of the parts ordered earlier had arrived from the UK, including some of the engine parts. Other parts yet to arrive and be manufactured include the wiring loom and upholstery. The chroming is now complete and

all the re-chromed parts are back at Spotless' workshops.
